MODIFICATIONS TO THE TUBE-LAUNCHED, OPTICALLY
TRACKED, WIRE-COMMAND MISSILE LAUNCHER FOR
THE BRADLEY FIGHTING VEHICLE SYSTEM

Report Number 98-165

June 25, 1998

Office of the Inspector General
Department of Defense

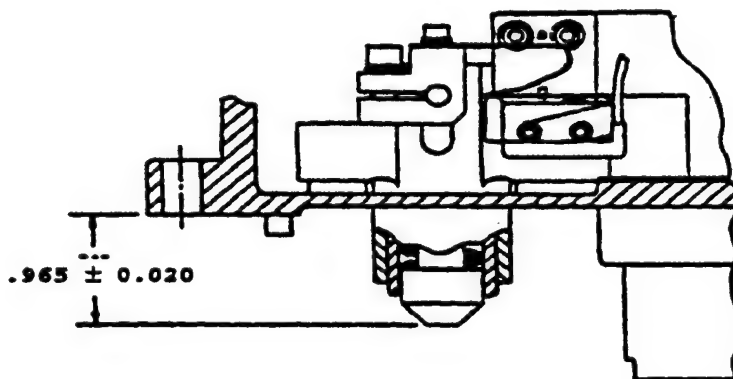
Figure 3. Umbilical Switch Specification

Alignment of Umbilical Switches. The DMWR requires the gauge set to align and test the ACU umbilical switches S1, S2, S3, and S4. Switches S1 and S2 are associated with the inboard launcher tube, while S3 and S4 are associated with the outboard launcher tube. The S2 and S4 switches, when activated, signal that a missile is present. The S1 and S3 switches, when activated, signal that a missile has been selected. According to the design specifications, those umbilical switches should be aligned to activate when the bottom of the holdback pin plunger is 0.965 inches, plus or minus 0.020 inches, from the bottom of the ACU housing as shown in Figure 3.

The S1 through S4 gauge assembly of the gauge set is used to measure the depth of the holdback pin plunger at the time the umbilical switches have been activated.

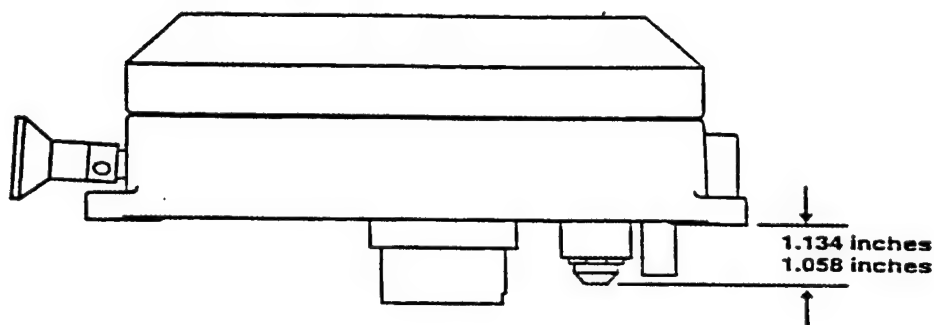
Figure 4. Holdback Pin Plunger Depth Specification

Alignment of Motor Stop Switches. The DMWR requires the gauge set to align and test motor stop switches S5 and S6. The S5 switch is the electrical limit switch for the extend function of the ACU motor. The S6 switch is the electrical limit switch for the retract function of the ACU motor. The S5 and S6 settings affect the distance that the holdback pin plunger and umbilical cable are extended when arming the system and retracted when disarming the system. The gauge set, specifically the S5 gauge assembly is required to ensure that the holdback pin plunger depth in relation to the ACU housing is between 1.058 inches and 1.134 inches, as shown in Figure 4, in order to satisfy design specifications.
